STOLL front loaders

Tolerance front loader lifting arm

Scope:	STOLL front loaders
Symptom:	Vertical and horizontal misalignment of the mounted front loader
Possible cause:	Incorrectly installed, force or manufacturing tolerance

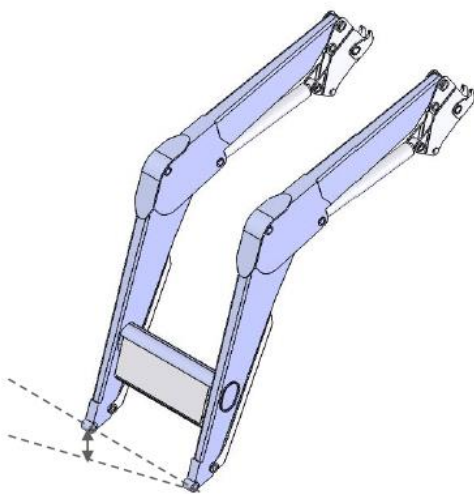
Vertikale Schiefstellung

(vertical misalignment)

The vertical misalignment refers to the difference in height measured at the lower pivot point of the change frame.

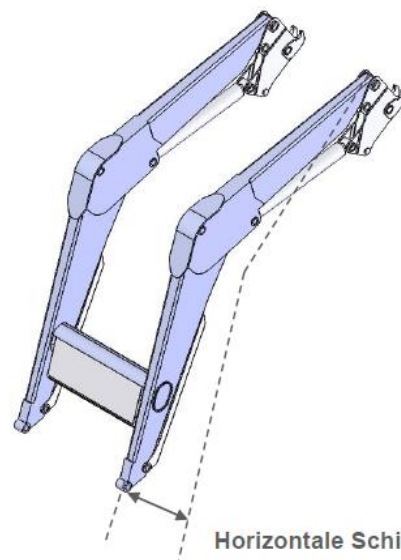
Horizontale Schiefstellung

(horizontal misalignment)

The horizontal misalignment refers to the lateral offset from the front loader to the tractor
