John Deere 6800 Lynx project:

Breathing new life into a 30 year-old Deere

John Deere 6800 Lynx Engineering project:

Lynx Engineering project John Deere 6800:

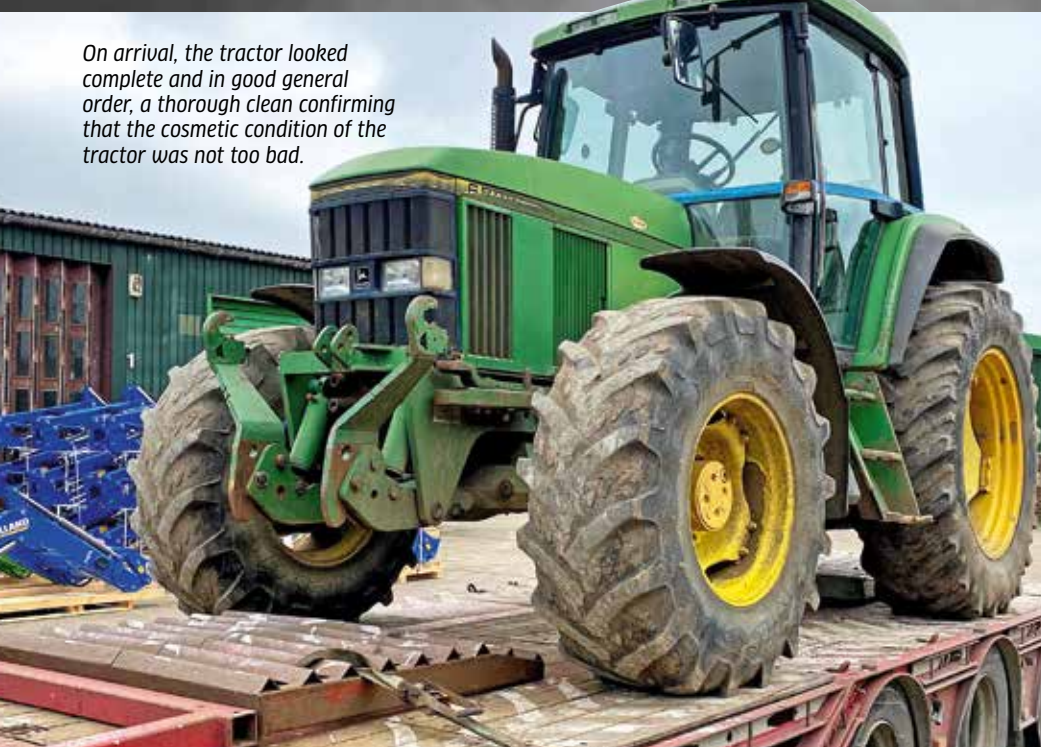
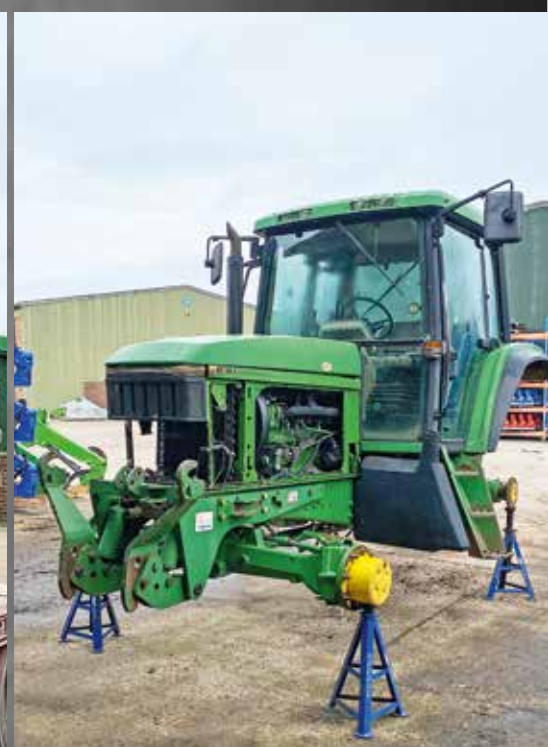
On arrival, the tractor looked complete and in good general order, a thorough clean confirming that the cosmetic condition of the tractor was not too bad.

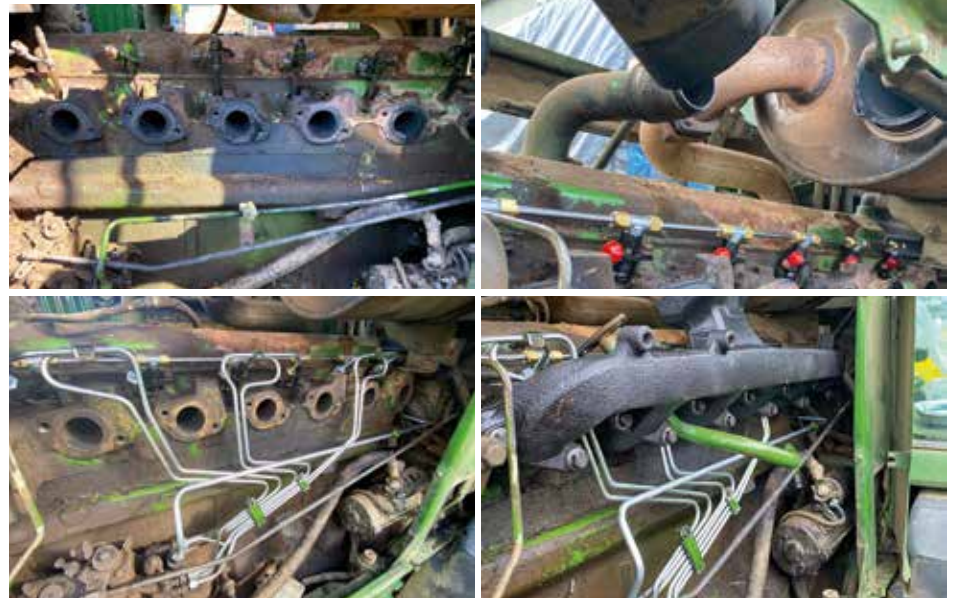
A rough running engine and poor starting was initially traced to the injectors. Their removal and replacement with refurbished items, plus new fuel lines, enabled the engine to be run and checked over, but this was just the beginning.

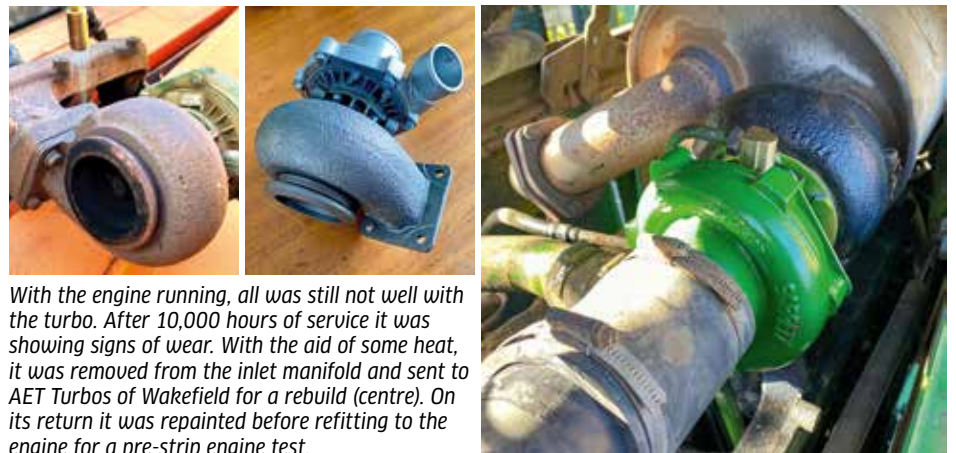
With the engine running, all was still not well with the turbo. After 10,000 hours of service it was showing signs of wear. With the aid of some heat, it was removed from the inlet manifold and sent to AET Turbos of Wakefield for a rebuild (centre). On its return it was repainted before refitting to the engine for a pre-strip engine test.

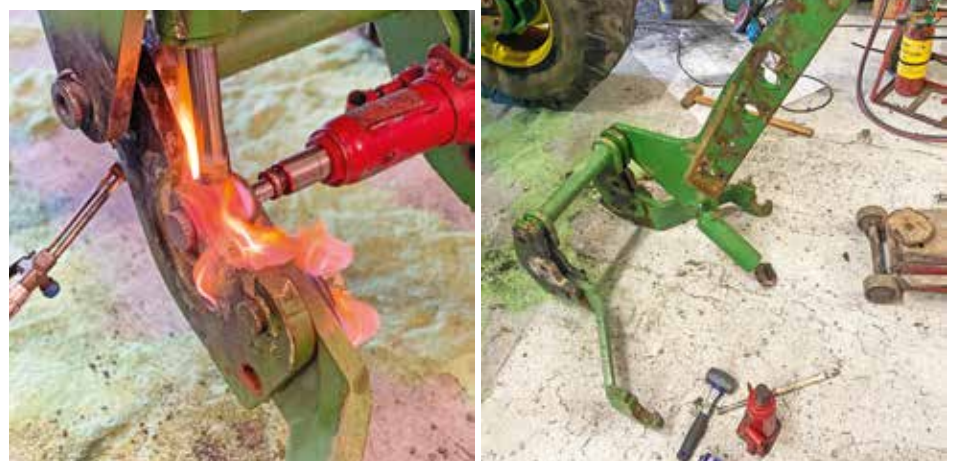
Thirty years of life on the farm saw numerous nuts, bolts and pivot points resist dismantling attempts, with heat facilitating the removal of the front linkage and its separate mounting frame. The linkage was in good condition but will be refurbished with new bushes and be joined by a freshly installed front pto with override system.

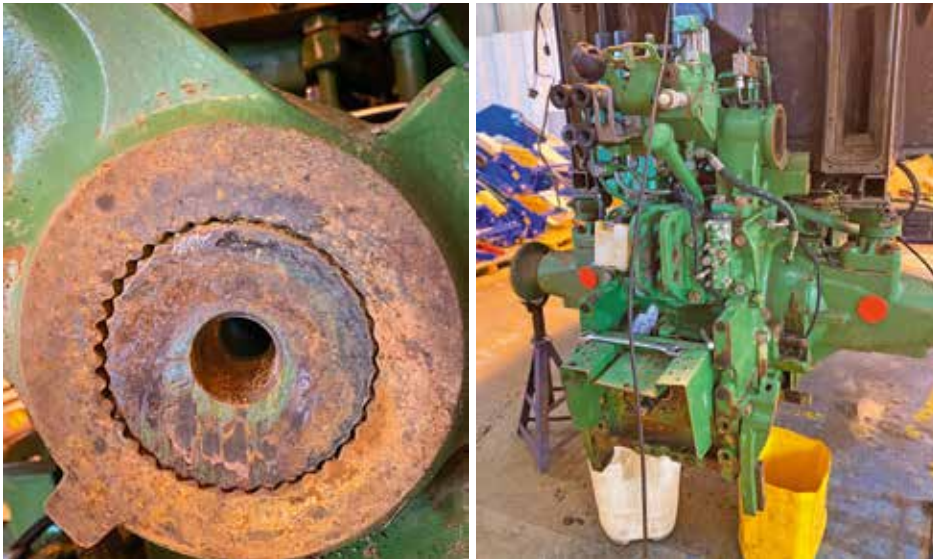
The cross shaft on the rear linkage shows wear typical of this generation of 6000 series, the back end of the tractor, prior to removal, otherwise presenting in good condition.

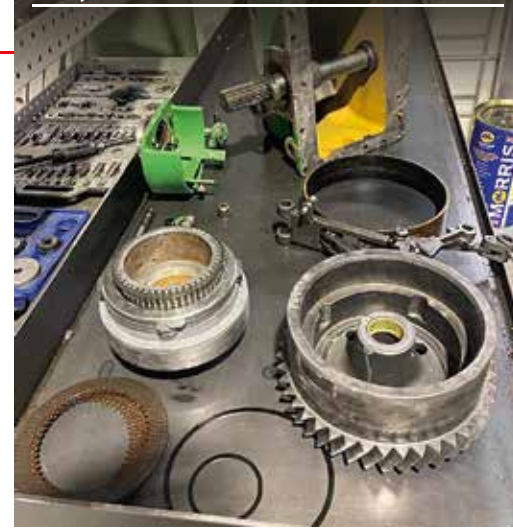
It was not until it was completely stripped and cleaned that the extent of the work needed on the transmission could be seen. From the clutch discs through to the brake band, new gearbox parts will cost in excess of £5,000.

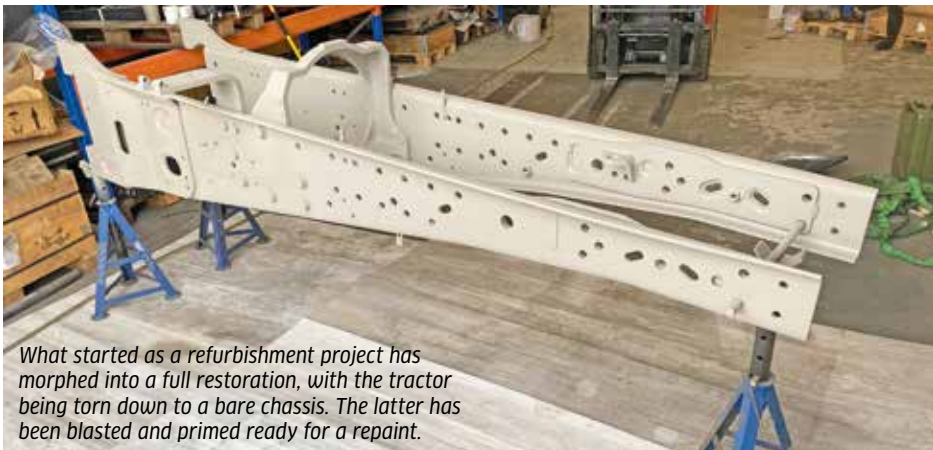
What started as a refurbishment project has morphed into a full restoration, with the tractor being torn down to a bare chassis. The latter has been blasted and primed ready for a repaint.

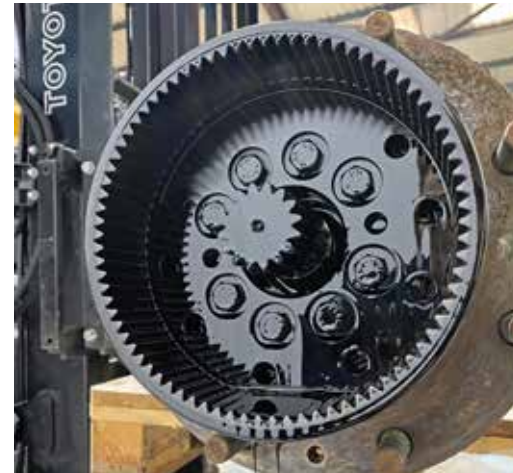
The oil in the front axle had not breached the hub seals, its black colour suggesting a lack of leaks also meant it was not checked or changed in a long time.

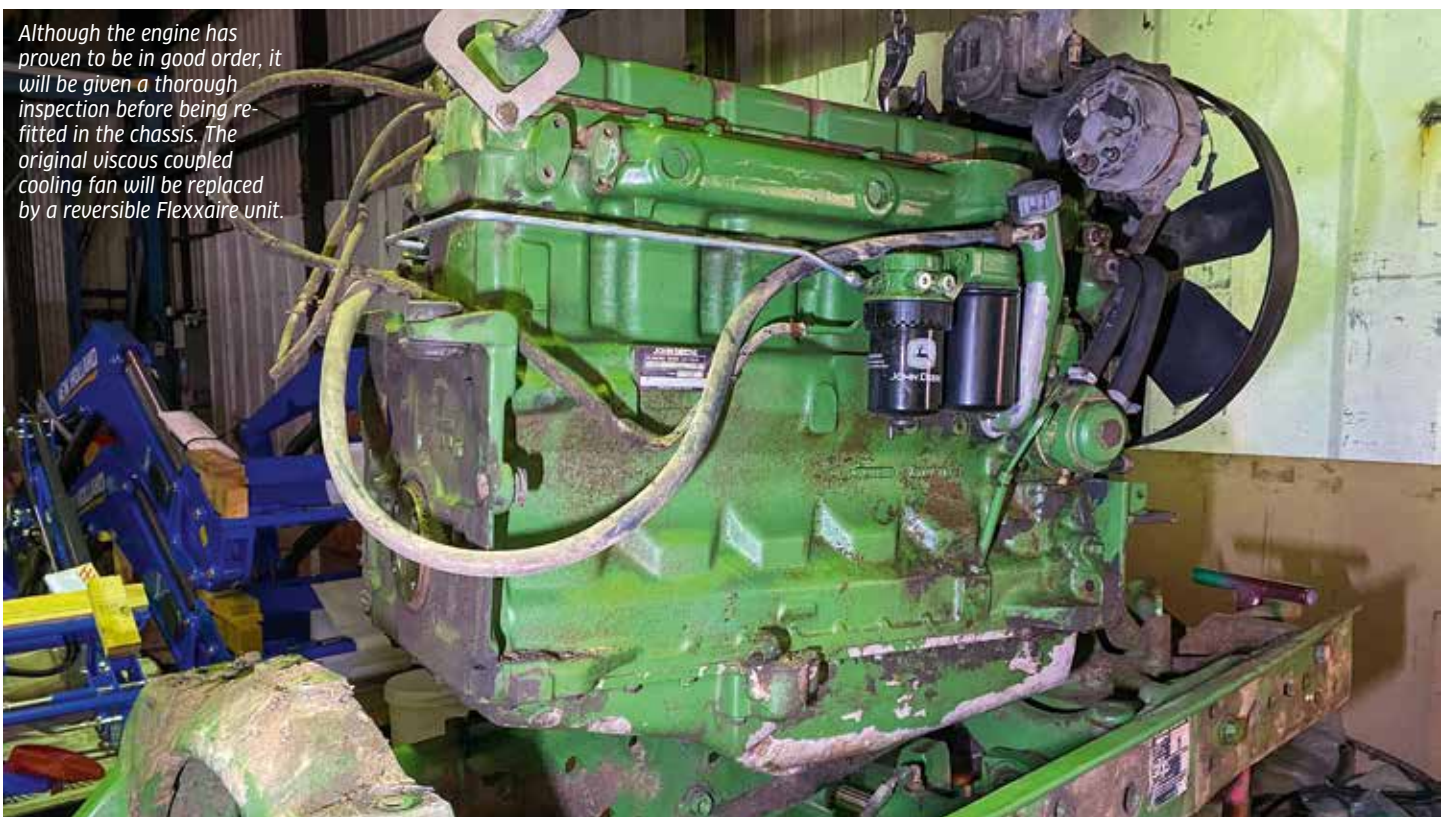
Although the engine has proven to be in good order, it will be given a thorough inspection before being re-fitted in the chassis. The original viscous coupled cooling fan will be replaced by a reversible Flexxaire unit.

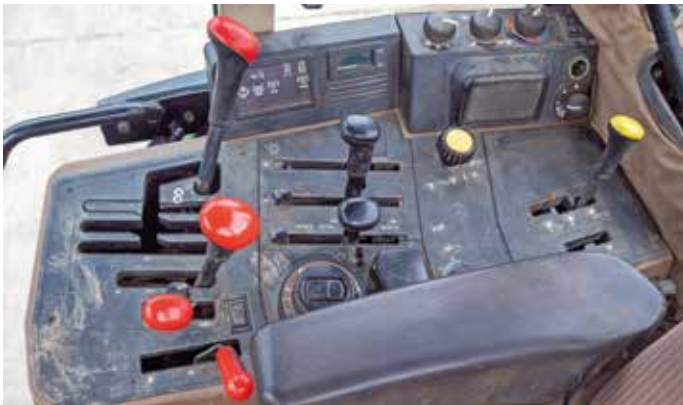
Fitted with a PowrQuad semi-powershift gearbox, the 6800 was a high spec tractor in its day. Although the tractor drove fine, a strip down revealed the transmission needed a full rebuild to bring it up to scratch.

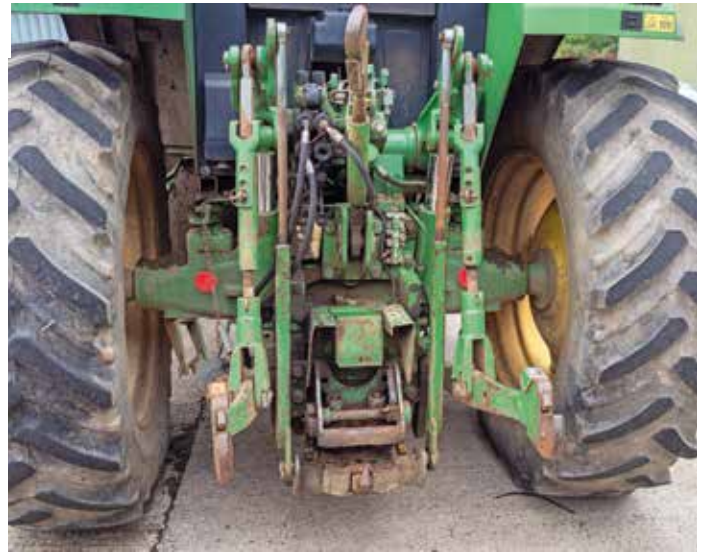
The Dromone rear pick-up hitch was well-worn and will be fully refurbished.

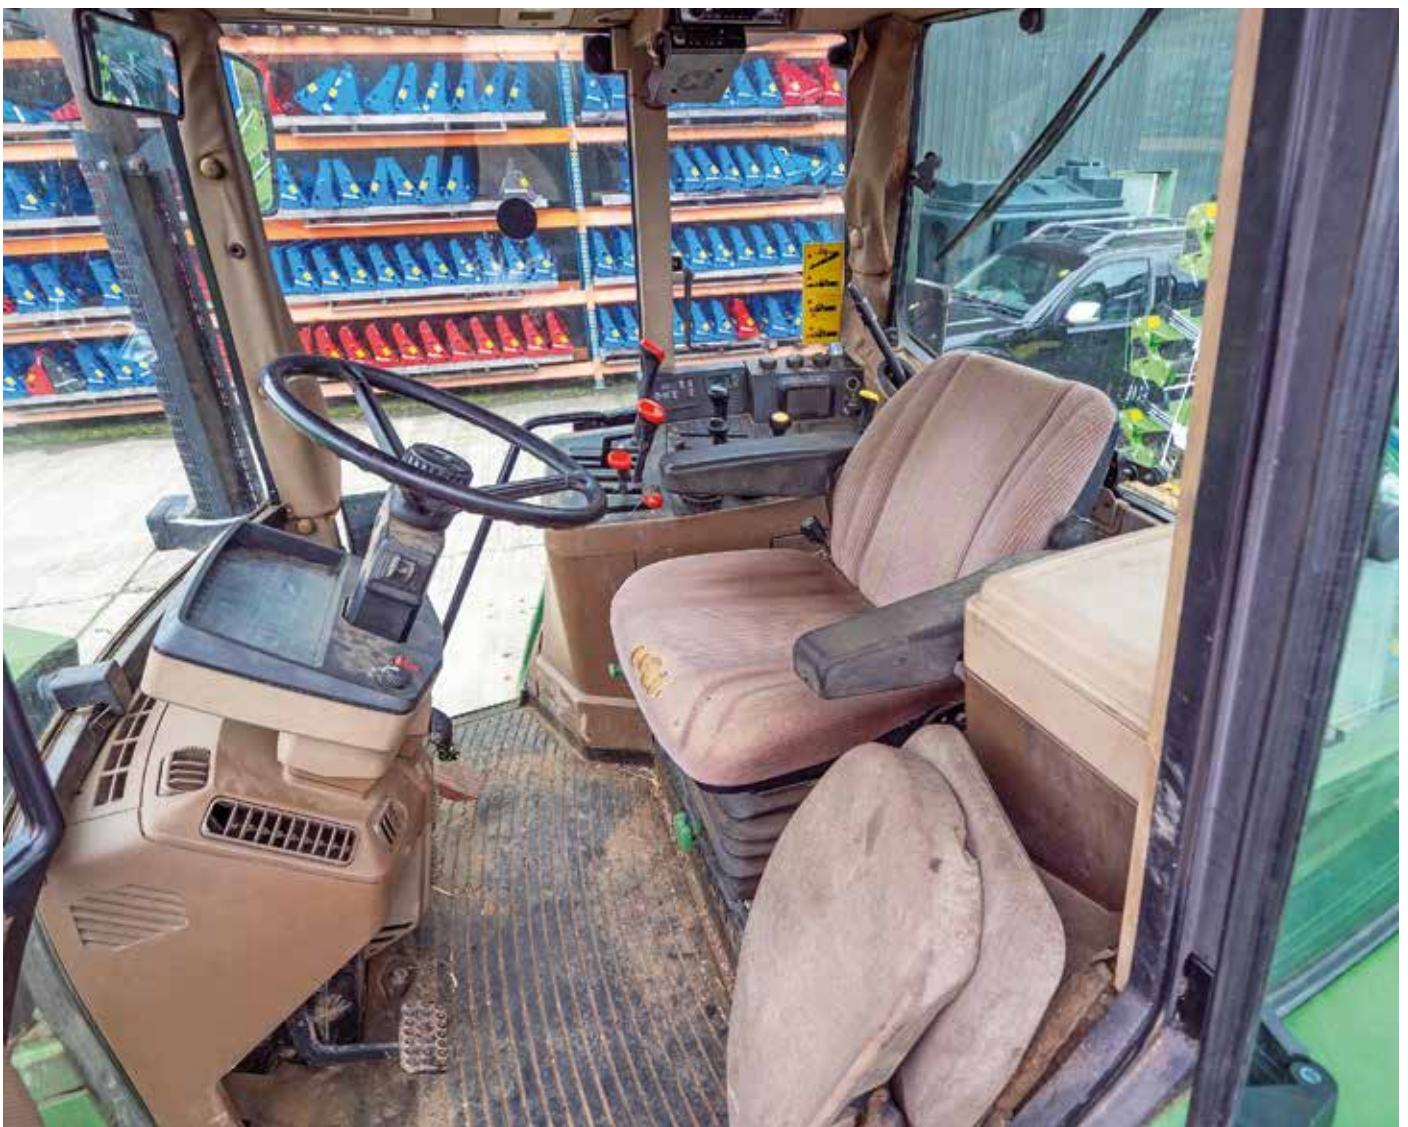
The cab interior has stood up well, with the slim pillars affording excellent allround visibility. The cab interior will be refreshed, enabling those who get a chance to sample the tractor a great insight into how tractor ergonomics, incab noise levels and overall comfort have evolved.

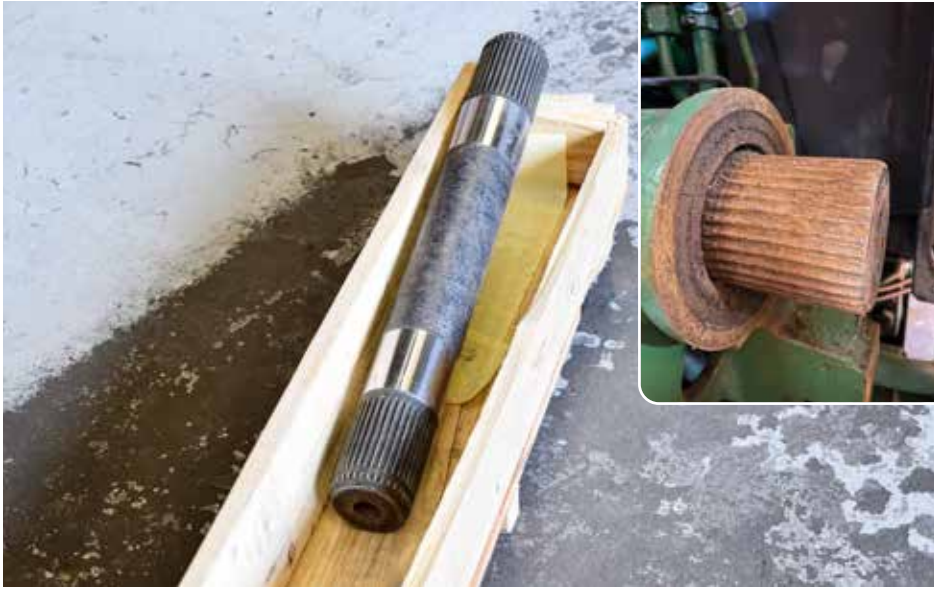
The cross/rocker shaft, that connects the upper arms of the three-point linkage, had severely worn splines (inset). A replacement part was listed as available from a pattern parts specialist for around £500, but after two months of waiting and still no sign the decision was made to purchase the genuine part which was in stock but with a significantly higher price tag.

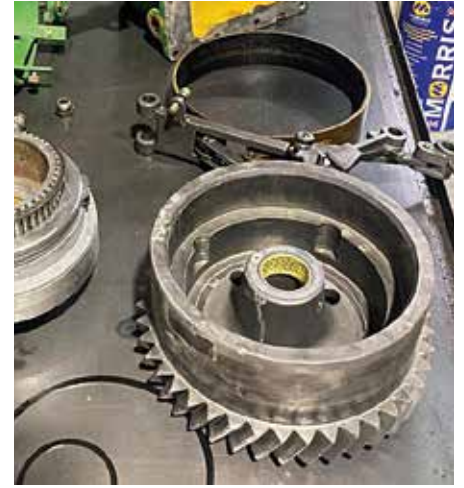
As part of the gearbox rebuild it was discovered the brake band had failed causing much of the damage within the transmission. Original 6000 series brake bands are no longer available but fortunately one from the newer 6030 series can be adapted to fit, with the added advantage of providing for a more robust repair. This is what is now nestling inside the fully refurbished gearbox.

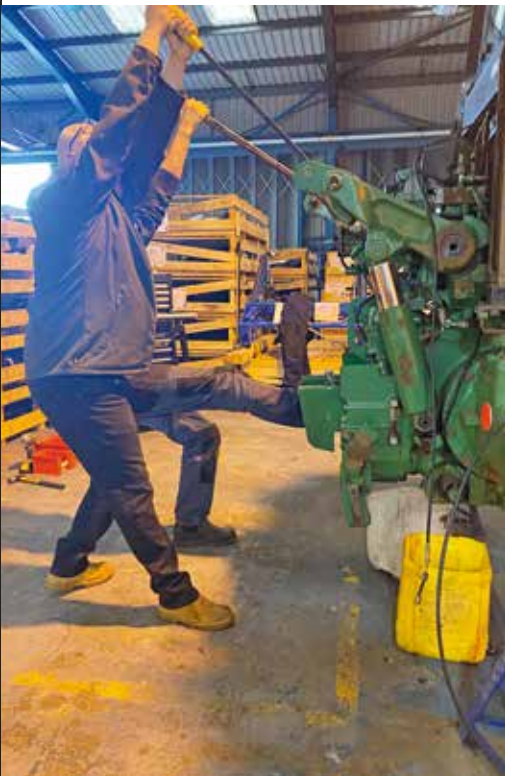
The back end required replacement of the main lift ram spigots due to a lot of wear. Luckily, they gave up with too much a fight and were removed without need for heat. The main lift rams are with a local hydraulics specialist for a rebuild to include new seals.

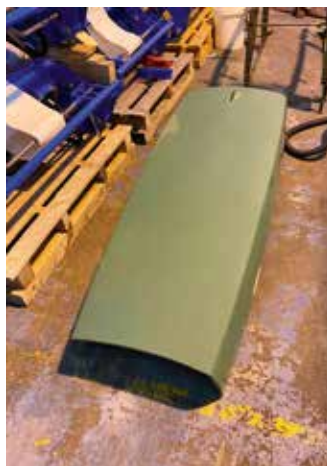
All painted metal, to include the bonnet, side panels, front fender mounts and rear mudguards, will be or have already been shot blasted and primed in a two-pack epoxy primer ahead of having a topcoat of JD green applied. Opting for a high-quality primer will ensure the new paint has high adhesion and will provide a good base for the colour coat. Talking of colour, John Deere green from the 1990s is a different shade to that currently in use. After asking for the paint RAL code from a friendly John Deere dealer, the team were informed that it the colour is just "John Deere Green". A colour match was taken from the inside of one of metal side panels of the tractor, a paint specialist then taking a scan. This will ensure the finish is correctly matched to the production colour applied to the tractor when new.

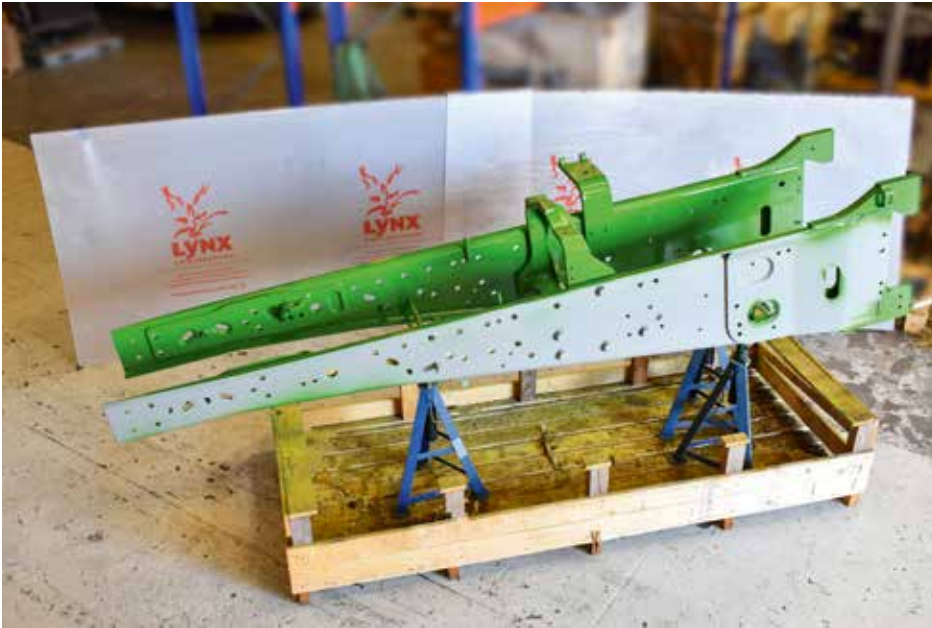
As shown in the previous article, the chassis has now been painted on the inside prior to the other main components being sprayed and installed. This is to ensure everything will be painted correctly in all the difficult to access areas before the re-painted main components are bolted back into the chassis.

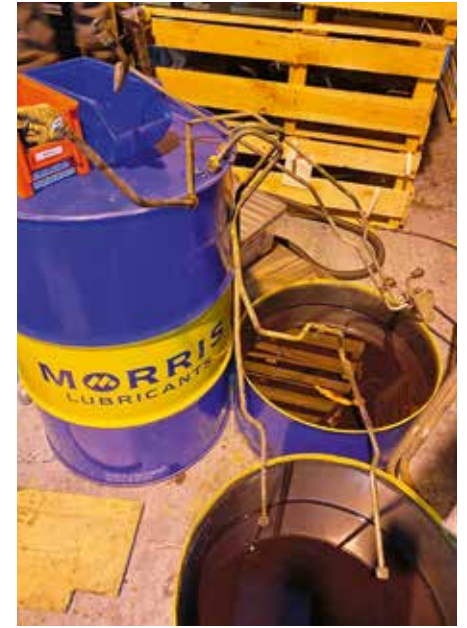
All the metal oil pipes that will be reused on the tractor have been given a flush. The dirt that came out from all of them was a reminder that cleaning forms an important part of a tractor rebuild.

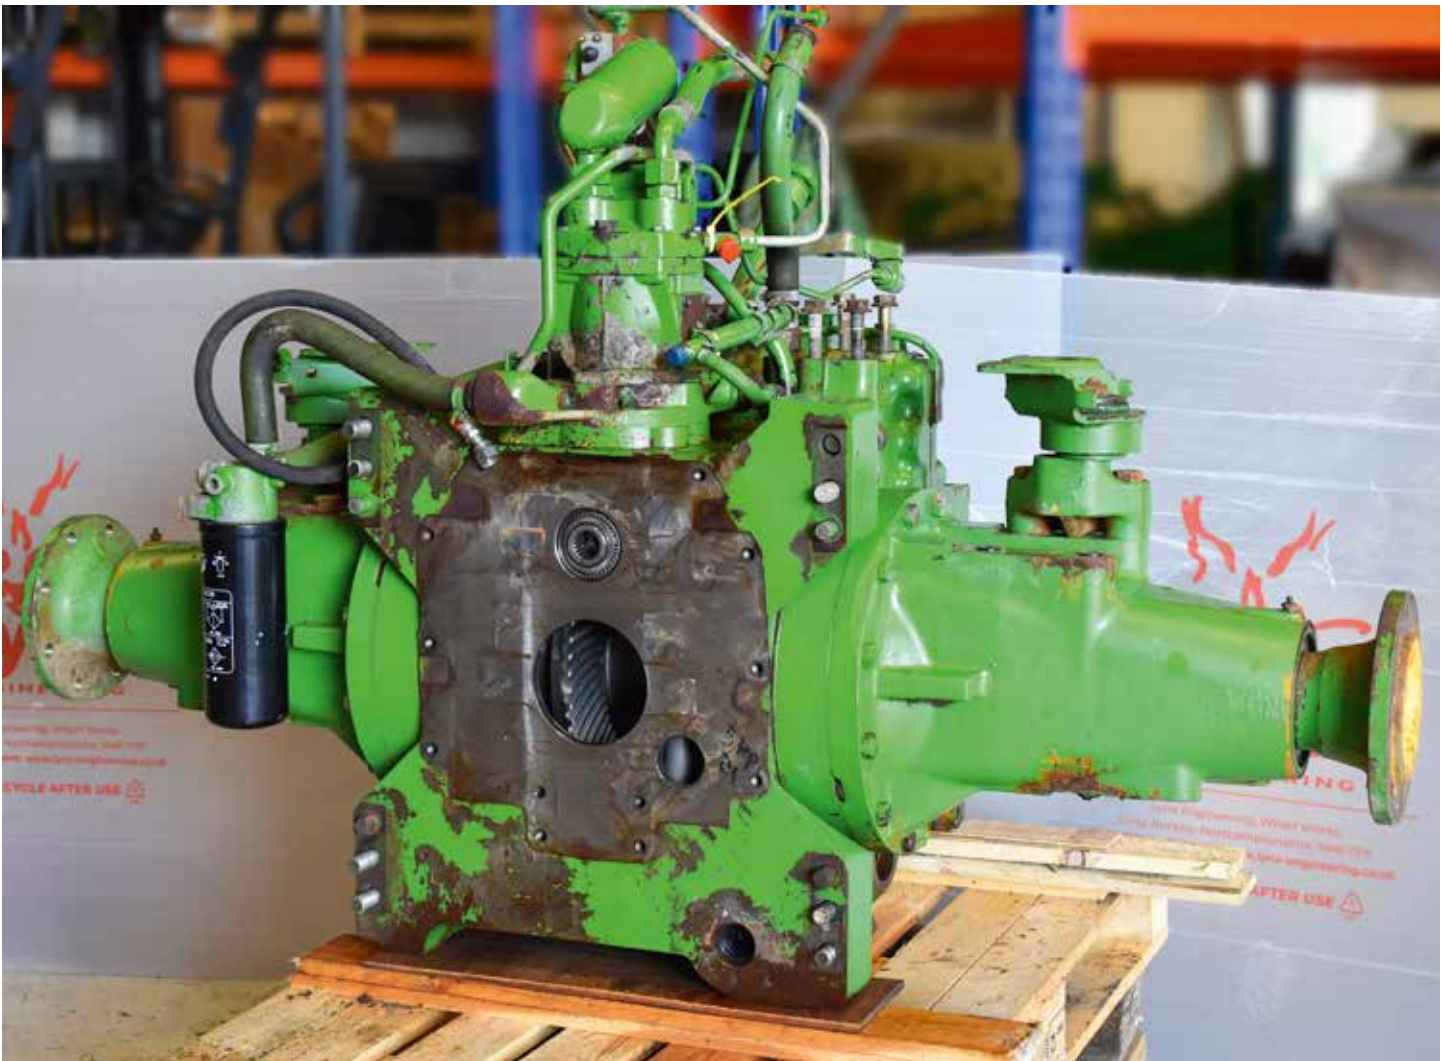
Cleaned and being readied for bead blasting, the rear axle has been inspected for damage and wear. It was in good overall condition.

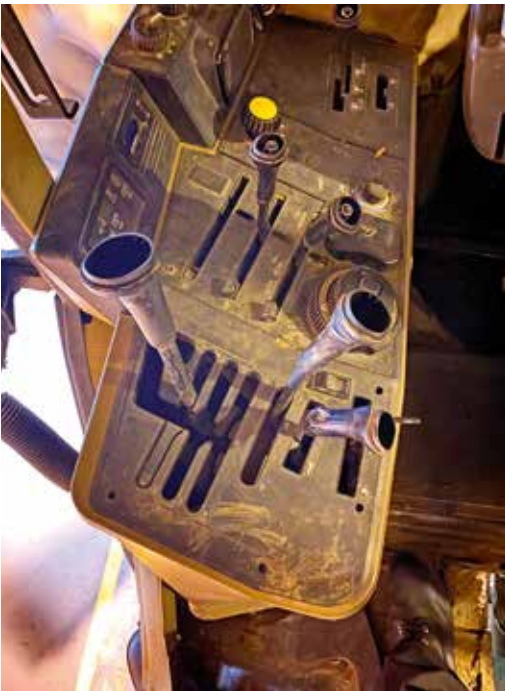
Popping off the lever knob end caps enables the nuts that hold them in place to be removed. The various knobs within the cab are in varied condition, a decision on what to renew being left until later in the project.

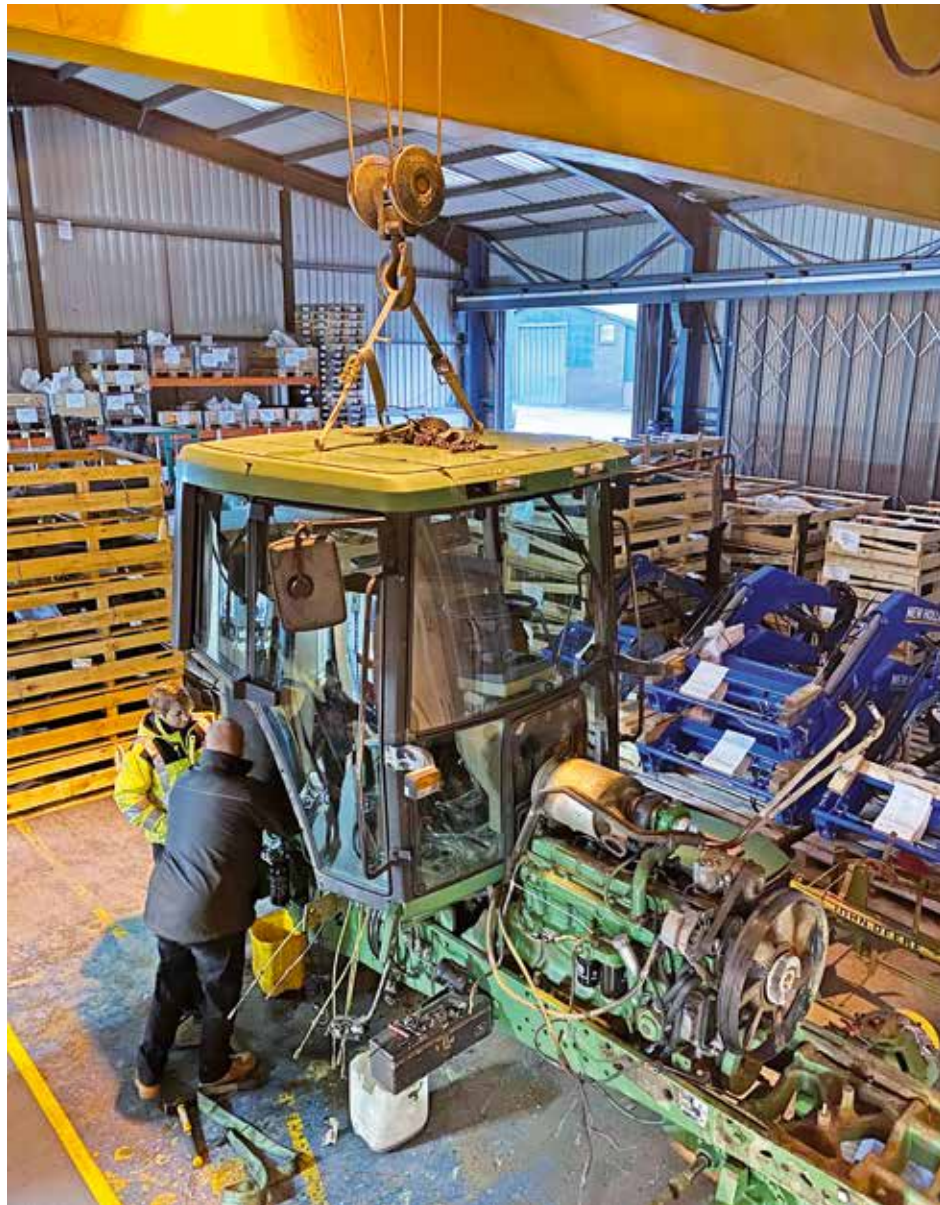
Removing the cab was a mix of the straightforward and nail biting, various cables and wiring being secured by all too easy to overlook clips and clamps. The cab will be subjected to a retrim, the original soundproofing material having degraded over time.

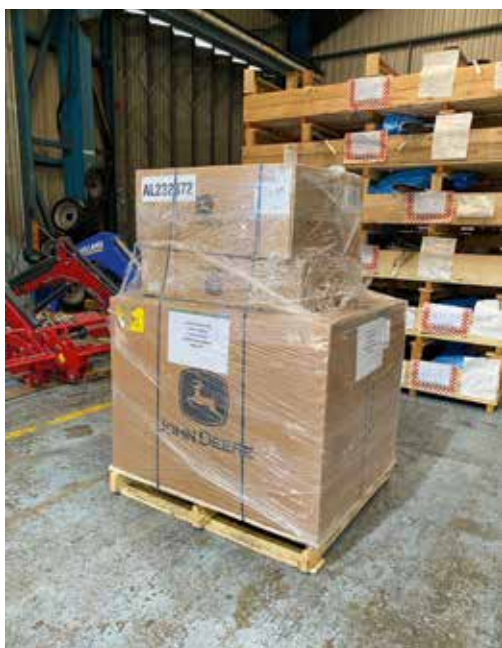
A surprising number of parts for the rebuild were available 'off the shelf' from John Deere.

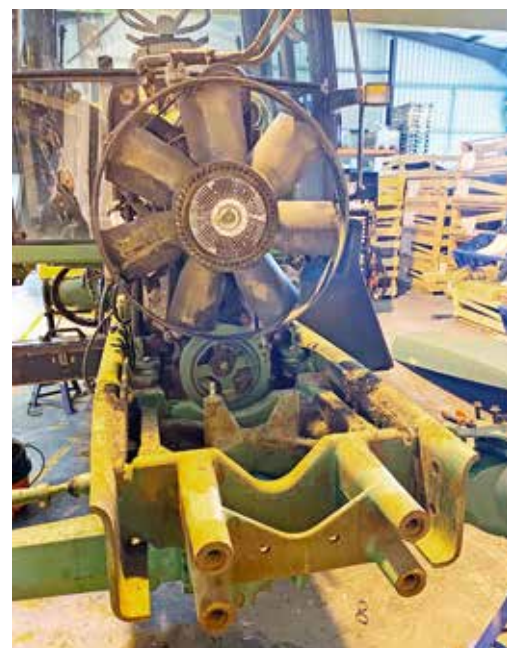
A Flexxair reversible cooling fan will be fitted in place of the viscous coupled original. The latter and the entire cooling system was found to be in good order, although the coolant drained from the system had clearly not been changed in many years.

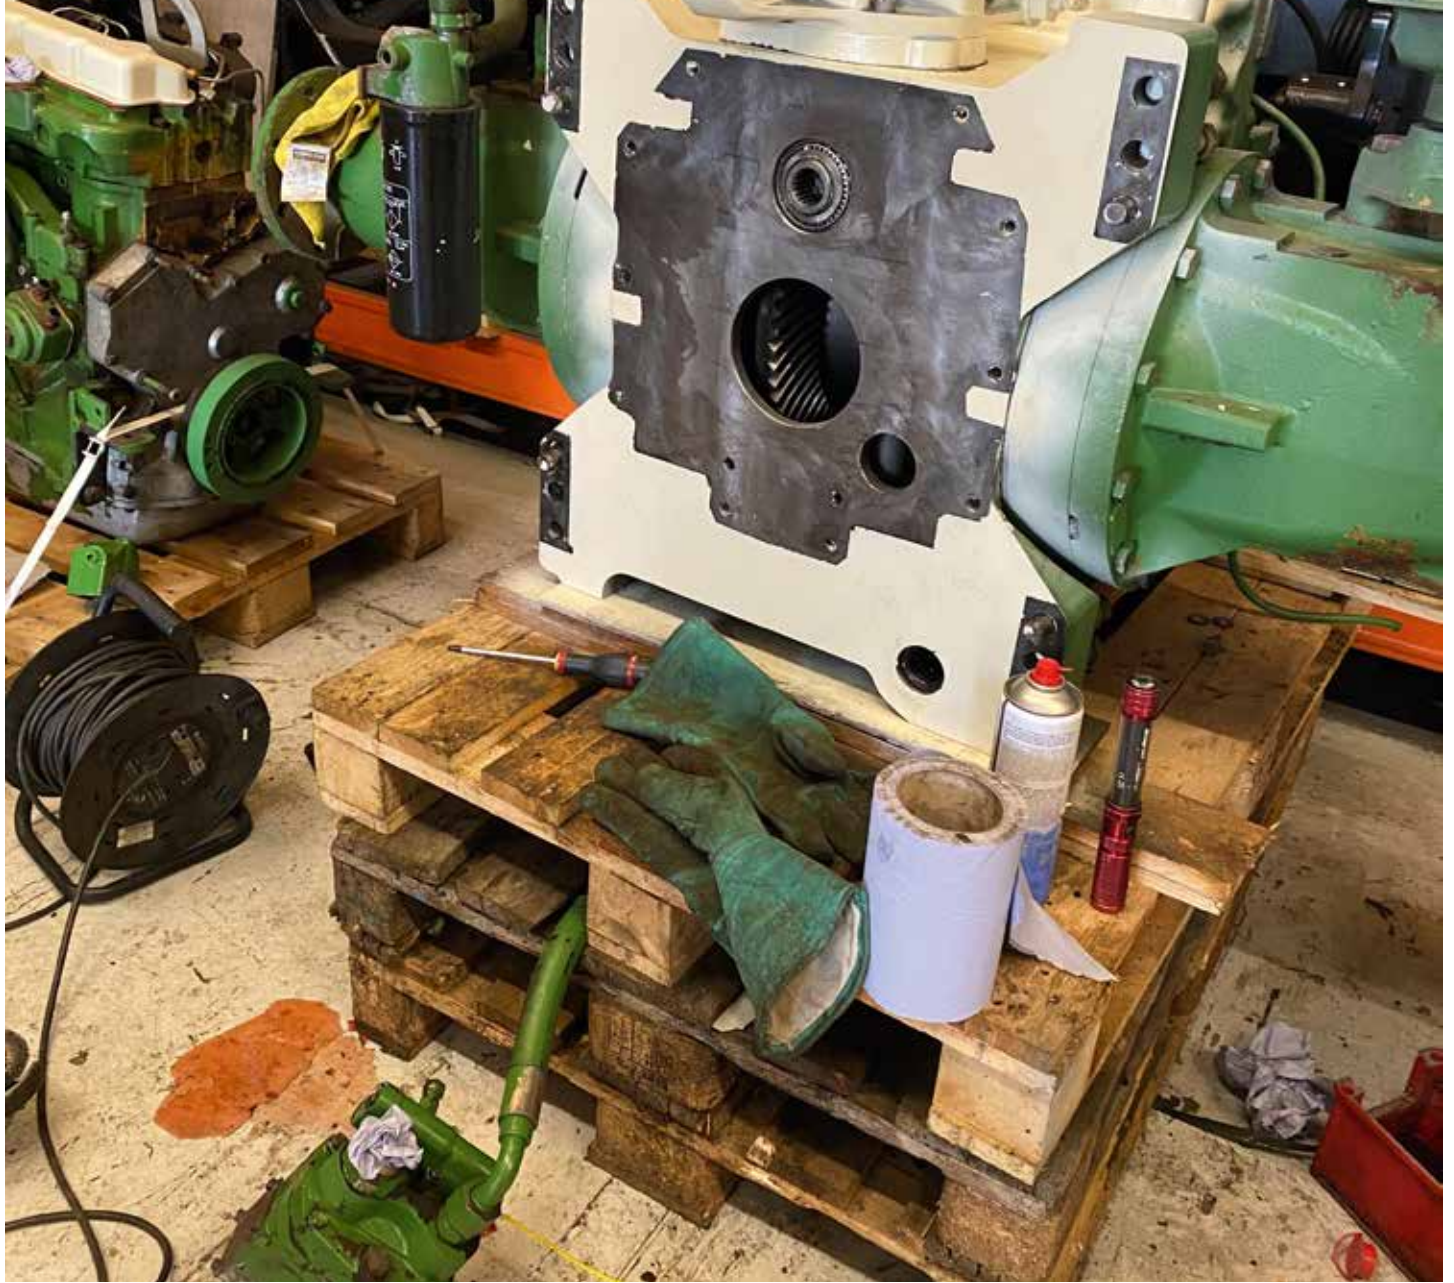
Once checked and re-assembled, the rear axle face was primed ready for paint with the joint surface masked off and cleaned for a leak free seal when refitted.

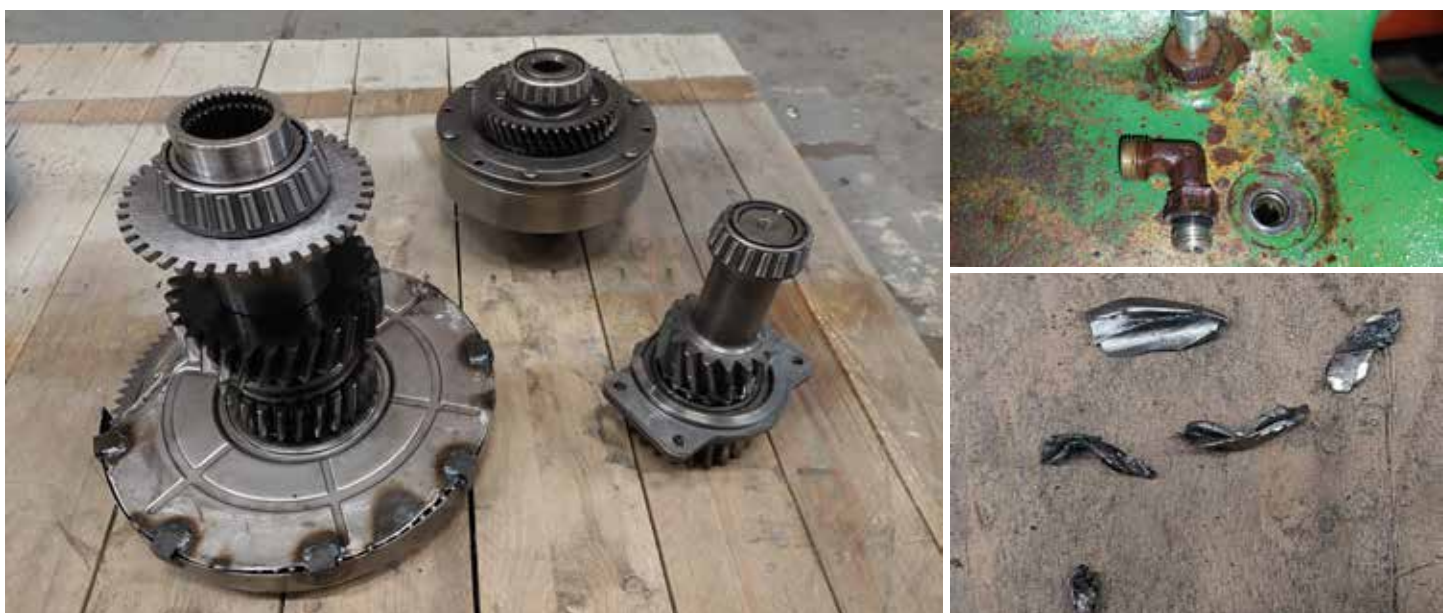
A rear axle leak needed to be sorted out, with one of the hose connectors on its last legs (middle). It was also found that there was an odd noise coming from the hydraulic pump when turned by hand. With the axle split, it was found the pump's oil guard had failed at some point but had been repaired (left). The guard cannot be purchased separately. Deere specialists at Cornthwaites suggested the guard could make a noise even when new, further examination showing the original repair had not included cleaning out swarf and fragments (right). Although scruffy, the existing weld repairs were sound and the gears were in decent condition so the the axle was reassembled and the halves re-joined using Loctite 574.

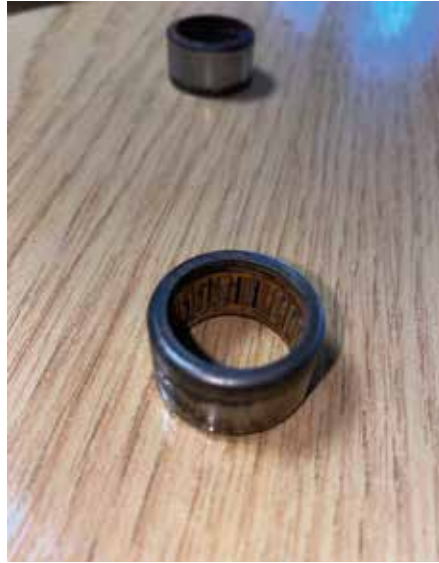
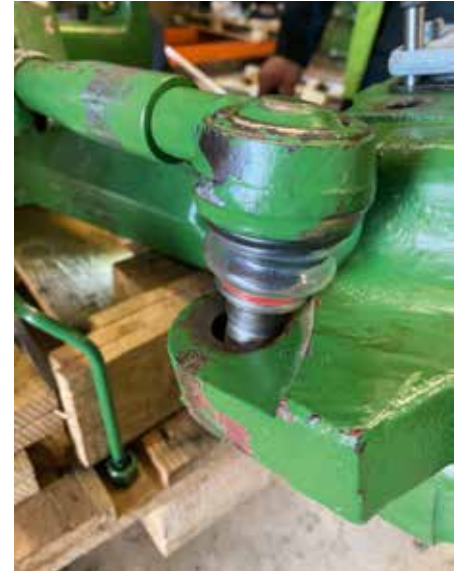
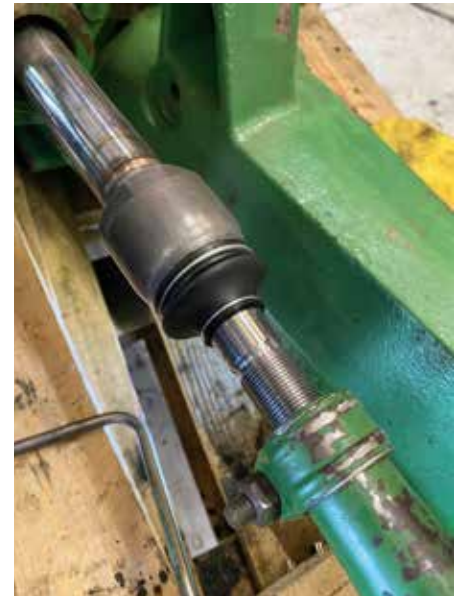
New track rod end boots, track rod adjuster joints and new pivot bearings were fitted to the front axle. Previously removed hubs filled with dirty black oil but no defects inside they were reassembled and will be colour matched with new wheel rims.

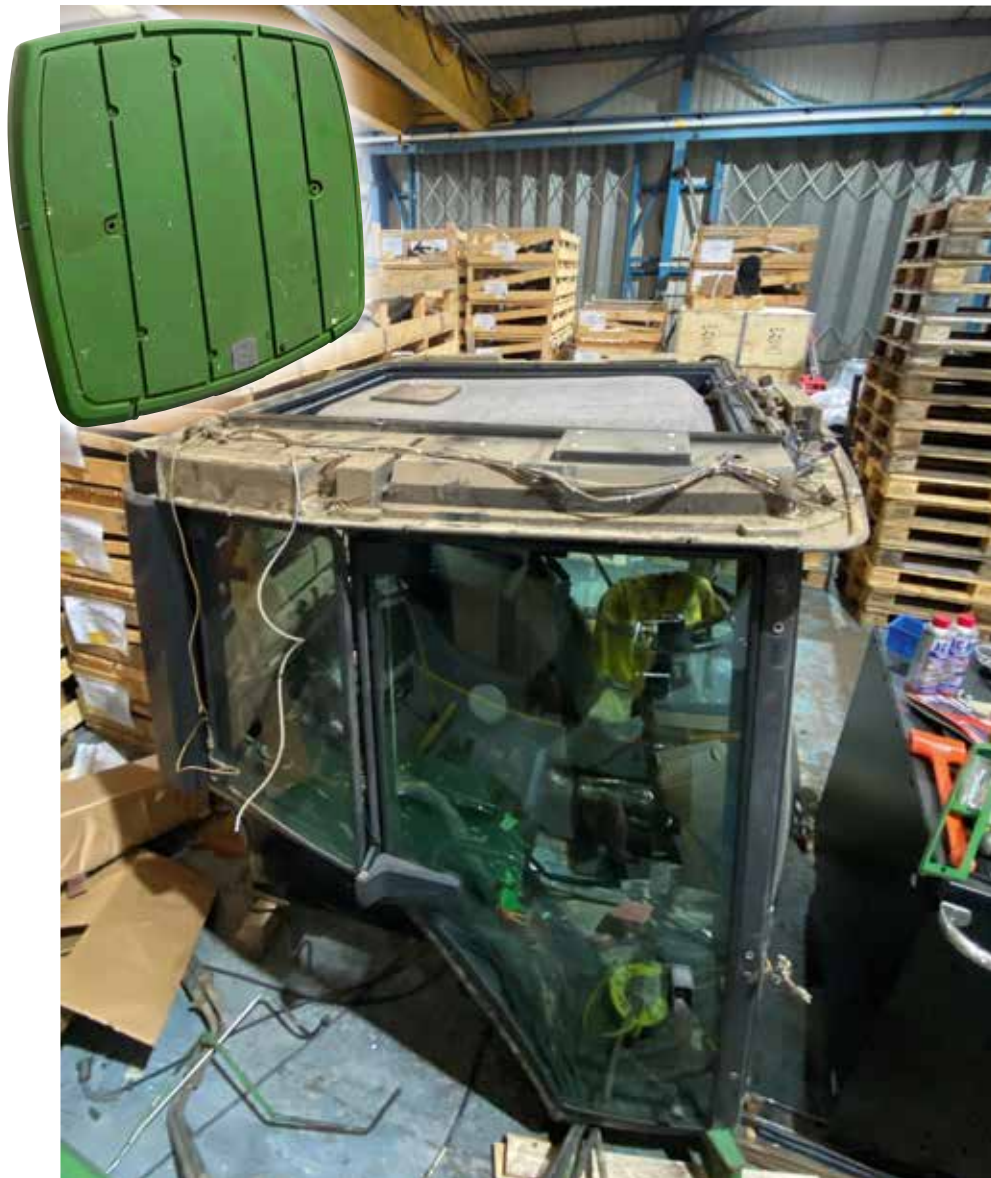
With the roof removed for painting, the sagging headlining was easier to get at but a new 'non-sunroof' replacement is no longer available. A fabric matched replacement will be sourced from either a UK or US based upholsterer and is yet another point that is holding up the build. Once all the sensitive parts and electrics are removed or covered, the cab will get a thorough clean.

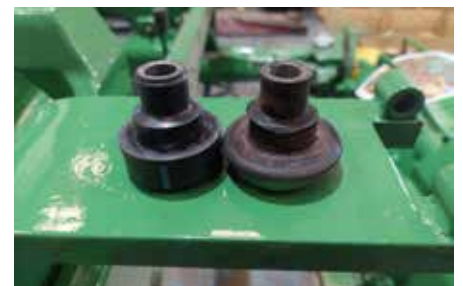
Greg Allen, a key member of the restoration team, has primed and painted all major and minor parts and installed new perishables, such as new mounts. Correct cap head chassis rail bolts have replaced hex head items, that were not of the correct hardness, and have been, like refitted bolts, torqued up as per the workshop manual. Attention to detail should ensure the finished tractor looks and 'feels' like it did when new.

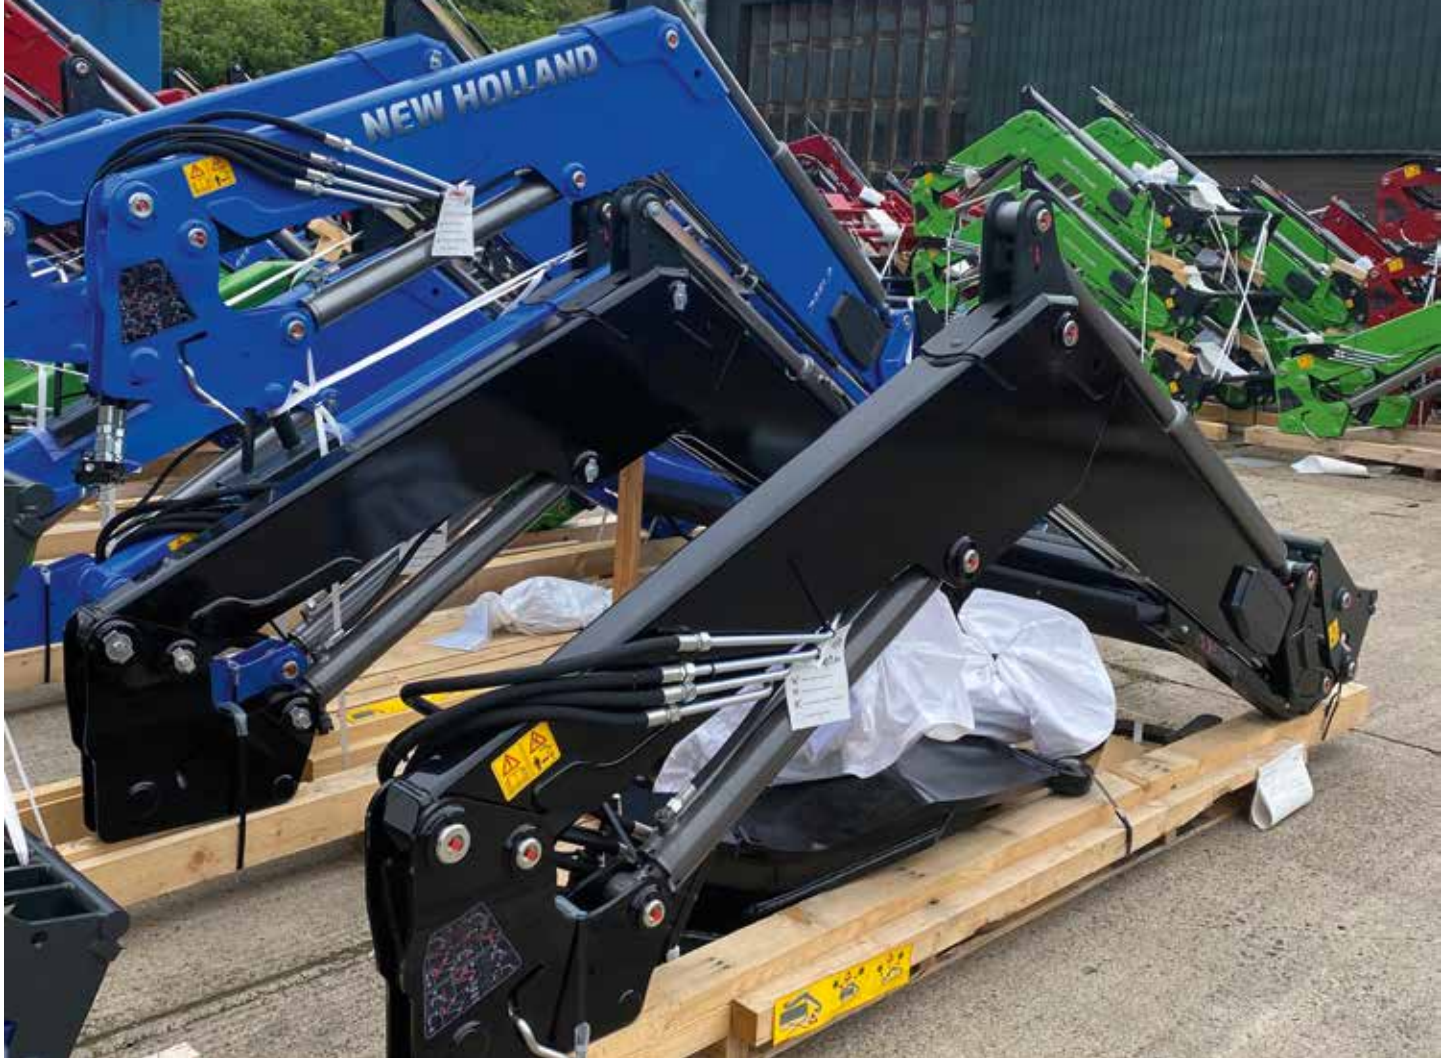
Despite the 6000 series now being over 30 years old, a new Stoll loader can be fitted, the pictured kit awaiting special 'yellow' decals for when it gets partnered with 'Project 68'. The headstock will need painting, as it is finished grey rather than the black that would have been applied when the tractor was new.

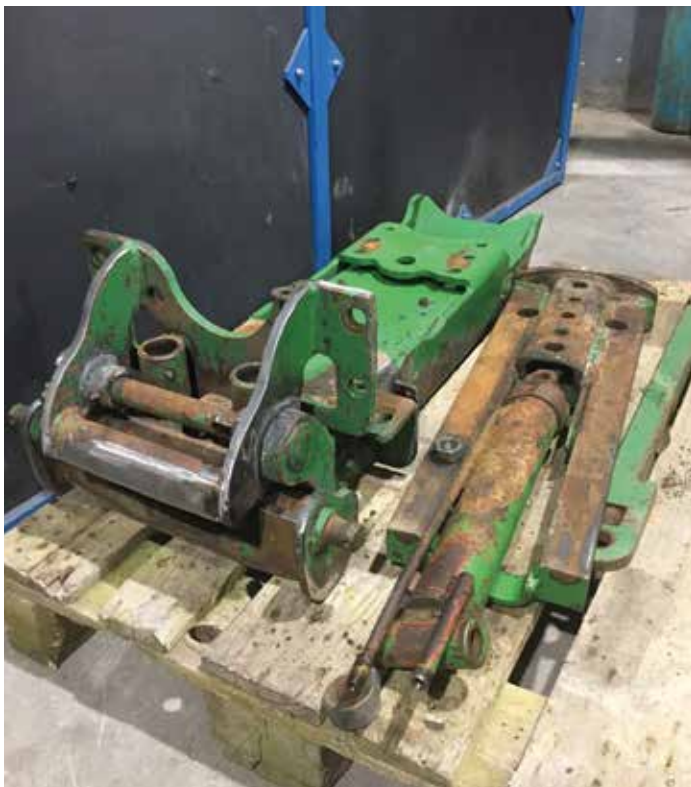
Refurbishing the original Dromone pick-up hitch is underway, this well-worn item needing a great deal of TLC to bring back to as new condition. The Flexxaire Fan will be measured up once the engine and radiator are installed.
