John Deere 6800 Lynx project:

Breathing new life into a 30 year-old Deere

John Deere 6800 Lynx Engineering project:

Lynx Engineering project John Deere 6800:

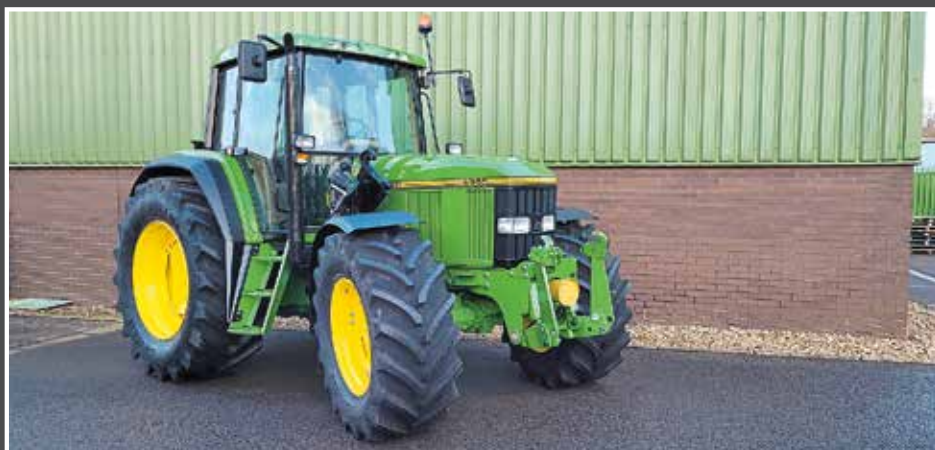
Fitted with taller and wider BKT 540/65 R28 and 650/65 R38 tyres, the completely refurbished Lynx John Deere 6800 certainly looks the part, particularly in comparison to how it arrived in October 2021. The original aim was to demonstrate how an aging tractor can be updated to match current demands, but the desire to get the tractor right saw the project take longer than planned. Next month we will look at some of the costs involved including fitting the various upgrades.

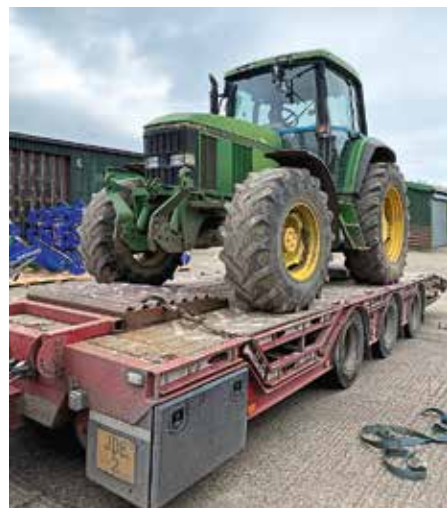
On arrival back in late 2021, the 6800 was fitted with 16.9 R24 and 18.4 R38 (metric equivalent 420/85 R24 and 480/85 R38) tyres. Fitting larger tyres transforms the overall look of the tractor, but other changes have also been made to bring the tractor up to date.

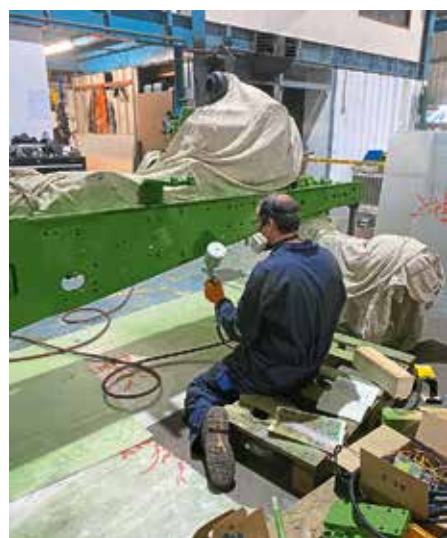
The engine, gearbox, axles and chassis were resprayed 'in-house', this also allowing various items to be repainted as appropriate as the rebuild progressed.

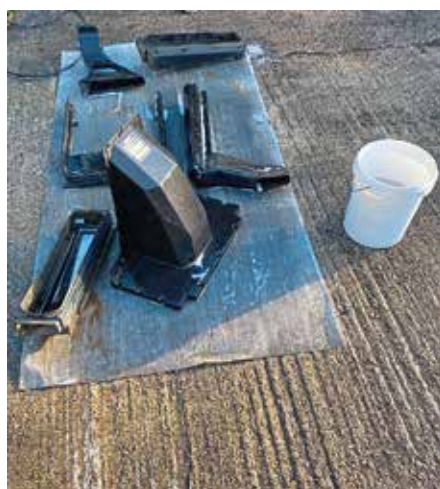
Moulded plastic parts are not easy to replace if damaged, with certain items needing to be repaired ahead of refitting. A great deal of time was invested in cleaning removed items, the quality of the original parts enabling them all to be reused on the finished tractor.

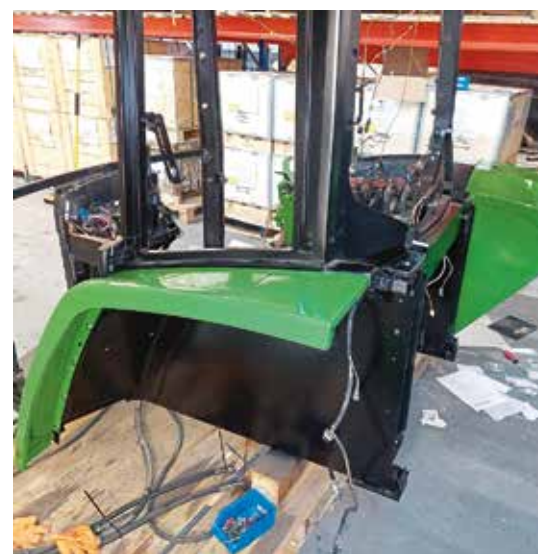
The cab was completely stripped, the frame receiving a fresh coat of black paint matched to the factory original.

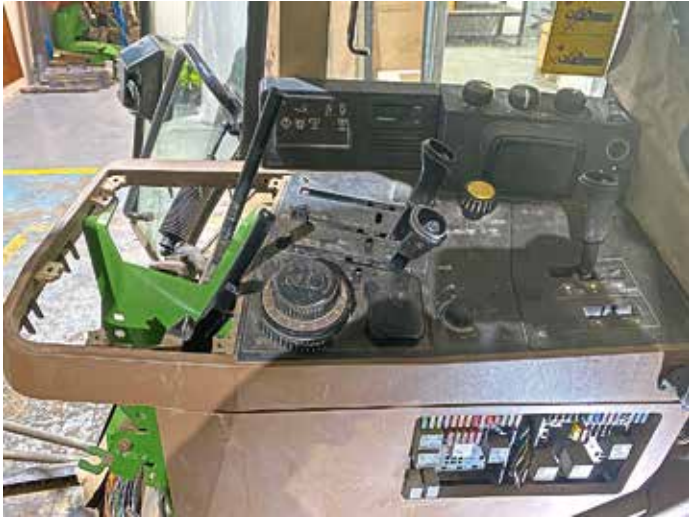
Notes of parts needed to refurbish the cab interior included sourcing new control lever caps from John Deere. Although the cab plastics were complete, a great deal of effort went into cleaning, strengthening and refinishing worn areas to give an 'as new' finish.

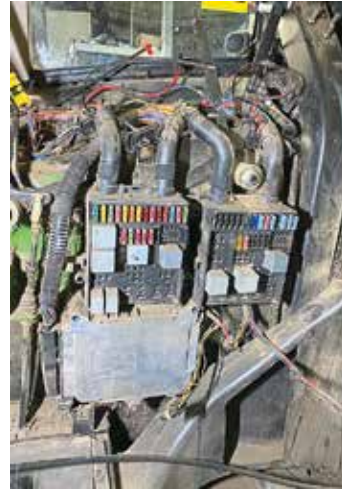
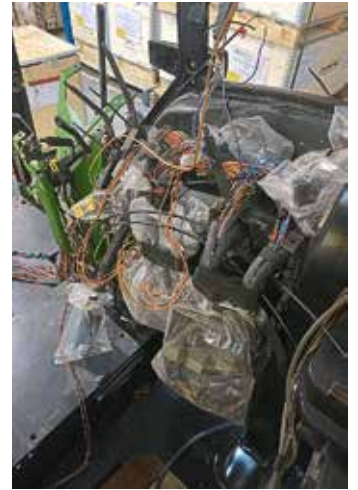
Although tractors made back in the 1990s have fewer electronics, that is not the same as suggesting the wiring looms are simple. Once internal cab cladding was removed, the amount of dirt found underneath reflected the tractor's hard life, all key connectors and fuses being covered ahead of a comprehensive clean.

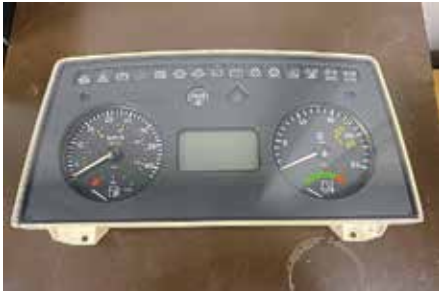
The dash binnacle was in good condition, with the instrument cluster responding well to a thorough clean. The scratched and faded Perspex was replaced and is now as clear as it was when new. The raised and white lighting and wiper symbols needed to be repainted, with certain areas of faded plastic being treated ahead of being airbrushed back to the correct colour. Restoring the areas the driver 'sees' was time consuming but just as important as getting the mechanical elements of the build right.

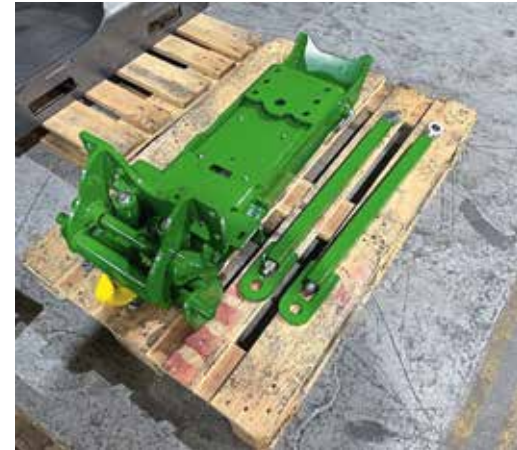
The original plan was to refurbish the worn pick-up hitch in-house, but Dromone offered to do the work in the factory, returning the unit in as new condition. Note the attention to detail, the hitch hook being finished in yellow as it would have been when fitted originally.

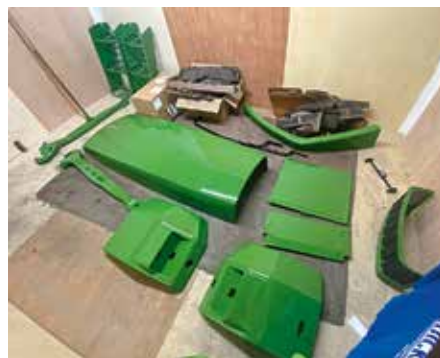
A 'dry room' was fabricated to house freshly painted parts to ensure they were protected up until the point of fitting. Easily lost or damaged components were also stored this way, taking pictures of removed bits and pieces where they were left helping locate them as the tractor was reassembled.

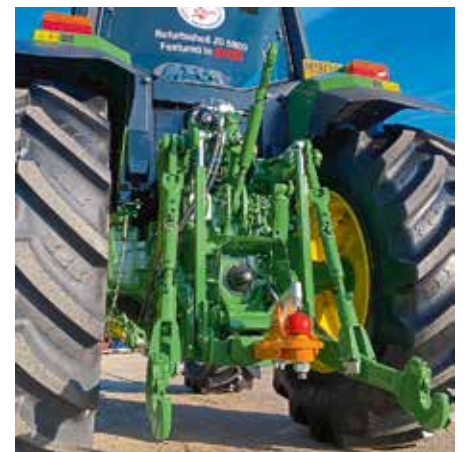
Completely refurbished to 'as new' condition, the rear linkage has quick couplers and a ball hitch fitted to bring it up to date.

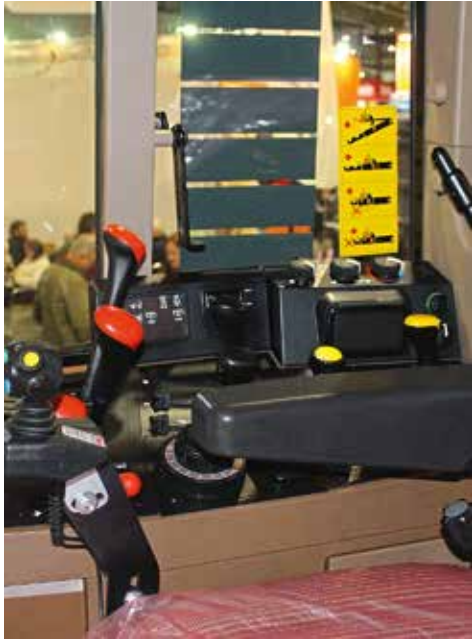
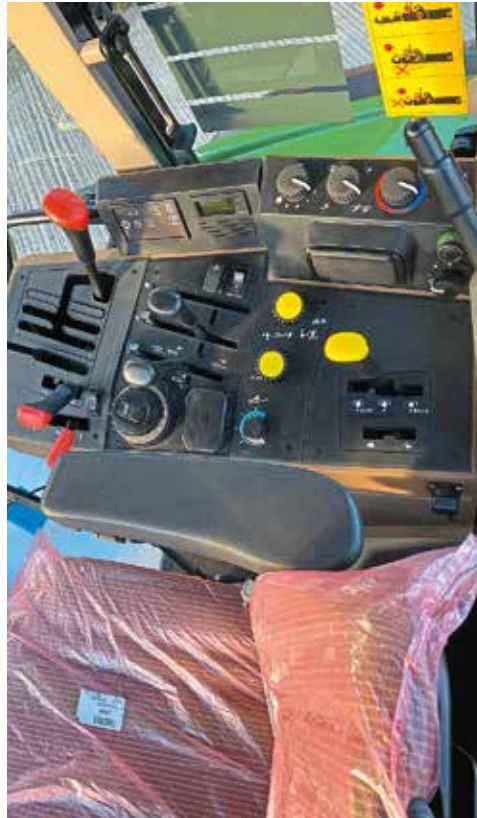
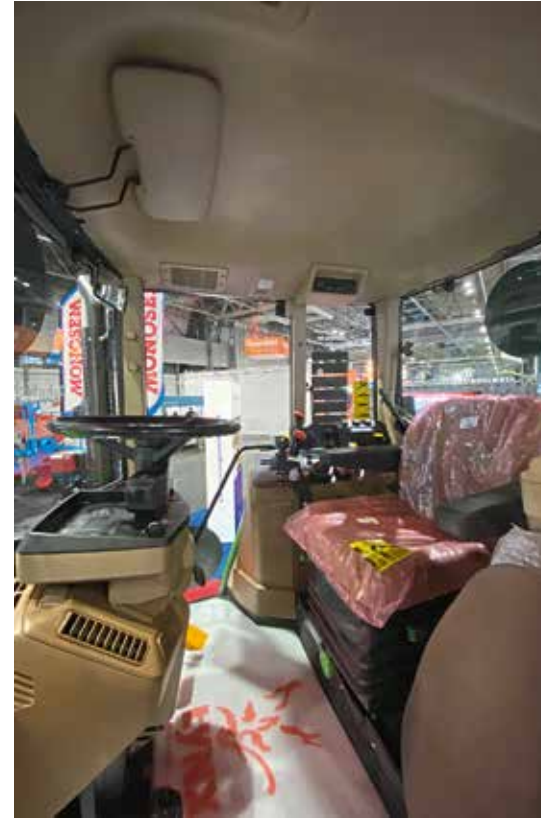
If you had jumped into a cab of a new 6000 series tractor thirty years ago, this is what would have greeted you with a notable exception. An electronic joystick for a front loader. A key aim of this project is to show an older tractor can be modernised to make it a viable working tool.

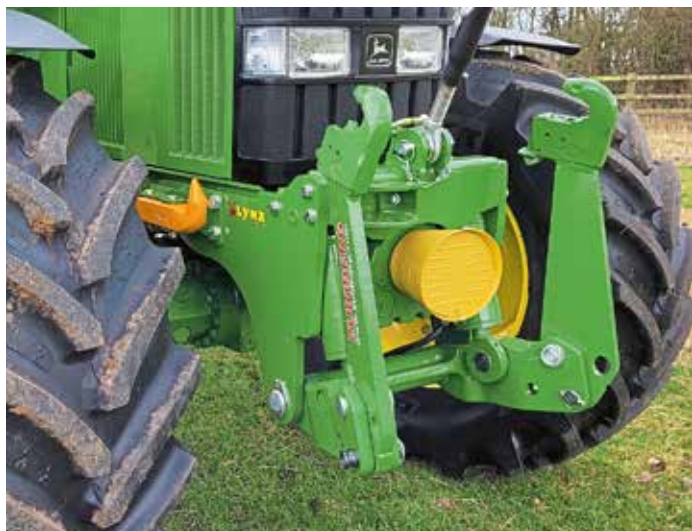
The Zuidberg front pto kit was added to complement the refurbished front linkage and benefits from a 'soft start' engagement system. Note the pick-up hitch hook mounted to one side, with space for the drawbar or ball hitch on the other.

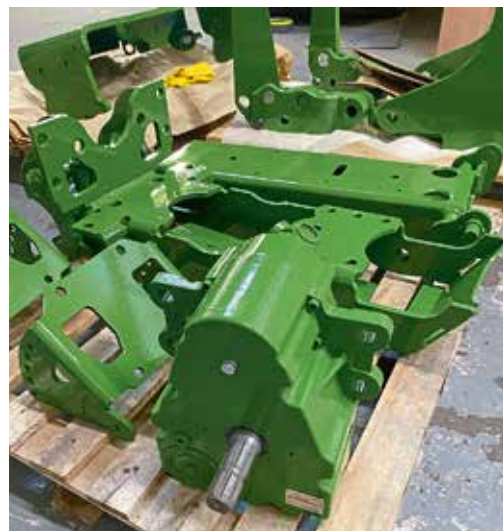
The front linkage mounting brackets bolt directly to the chassis of the tractor, with large lift rams ensuring the nominal 2.8 tonnes of lift is delivered swiftly. With around 100hp available at the pto, this set up will easily handle a 3.0m front mount mower.

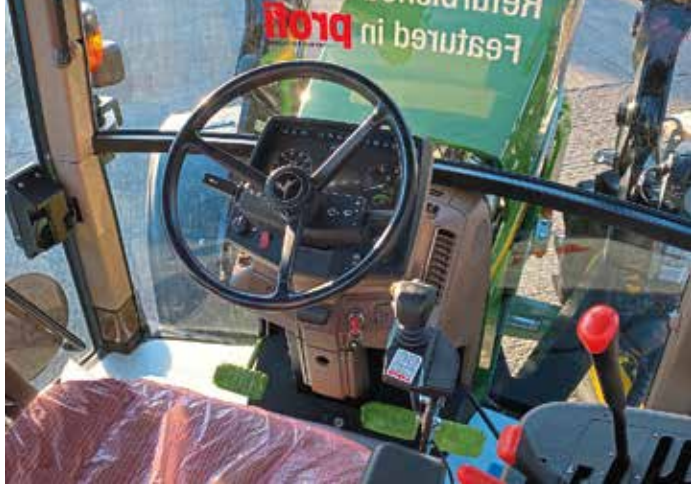
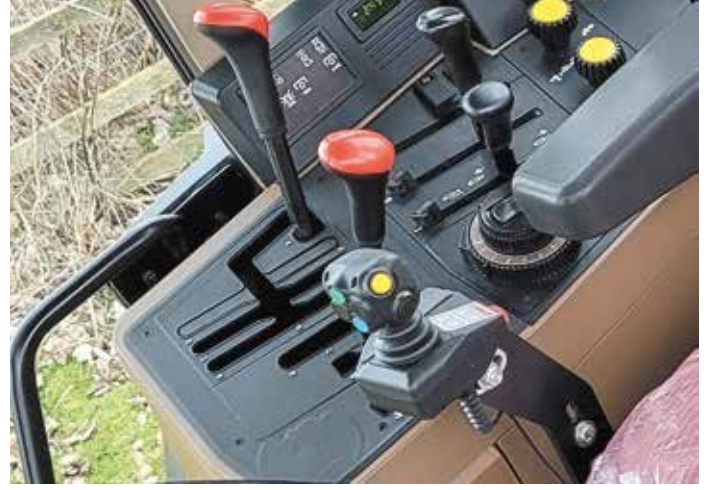
Modern Stoll ProControl joystick does not look out of place in the cab, the tractor's ergonomics standing up well when compared to a current tractor model. The build quality of these John Deere tractors was good, although heavy-handed fiddling with the dash vents could see them break. For the most part, the majority of the cab fittings are the originals.

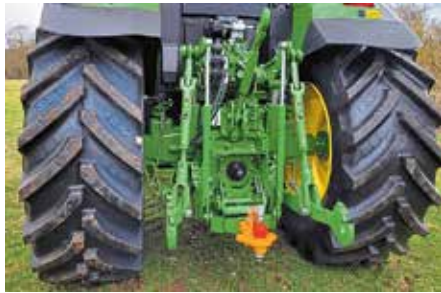
Even by current standards, the near 6.8 tonnes of rear lift capacity is decent although the rear pto offers no ECO speed settings. Note twin lift rams and both lower links having height adjustment. Side and rear fender extensions are not original but are OEM Deere and necessary to cover the fatter rear tyres.

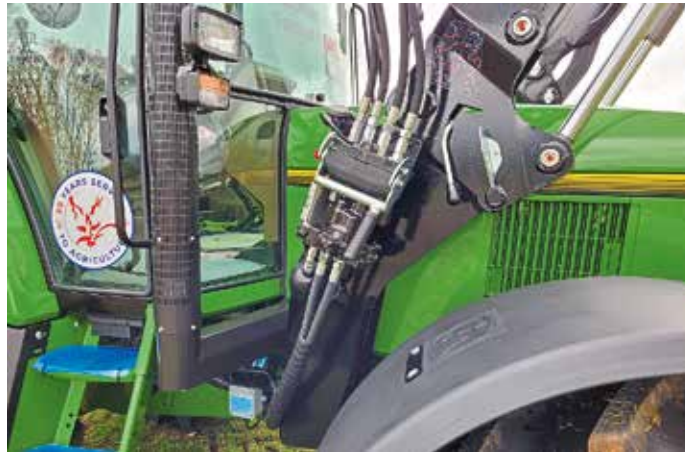
Hydro-Fix quick coupling was offered back in 1992 but the current design also incorporates the electronics. The loader is plumbed into the rear spools and shares its circuitry with the front linkage. Comfort Ride boom suspension is fitted to the Stoll ProfiLine FZ43-27 loader.

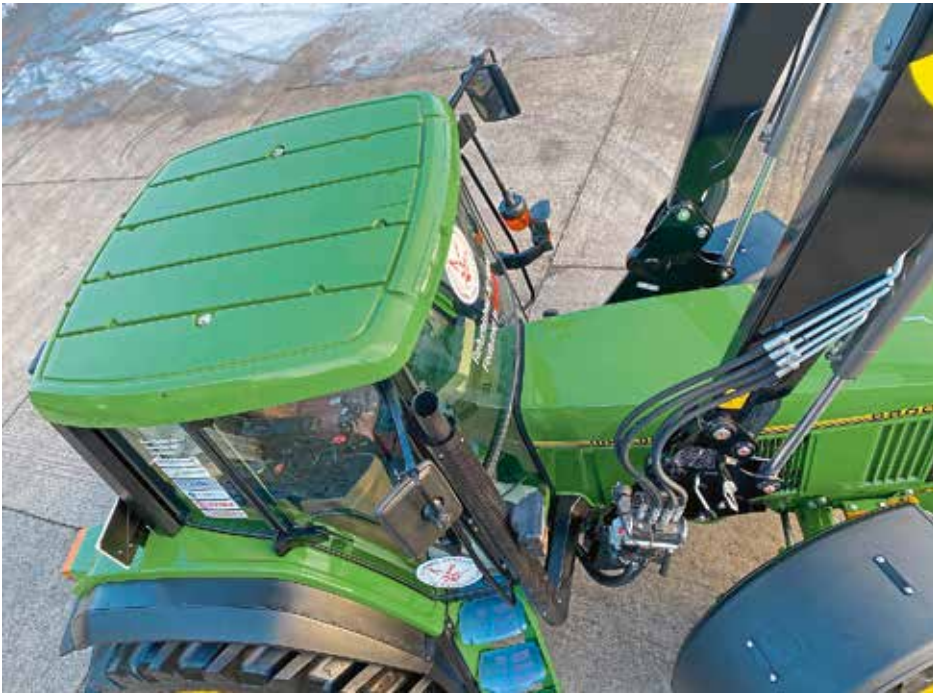
A solid roof, without hatch, is less common which in turn led to problems when it came to sourcing a new headliner for the cab. Note the amber beacon folded down beside the cab and the almost dainty exhaust stack. Visibility from the 6800 cab is excellent.

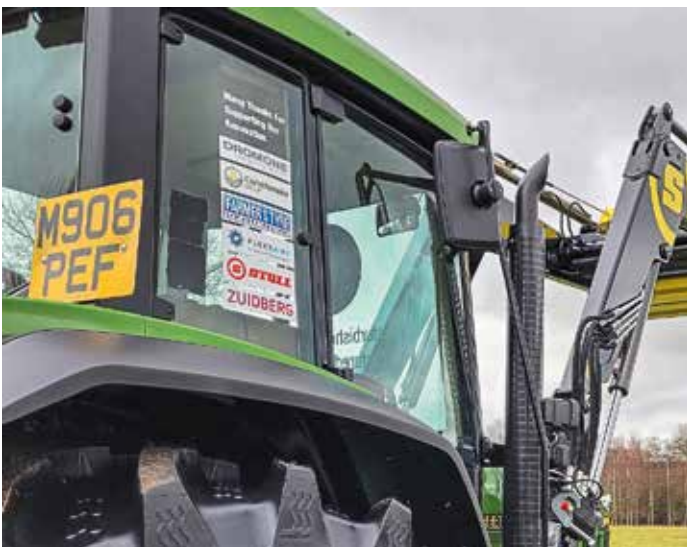
MF906PEF had three previous owners, the tractor serving on farms for nearly 30 years. If it is pressed back into service it could well do the same again. Note decals thanking those who helped support the tractor's restoration.

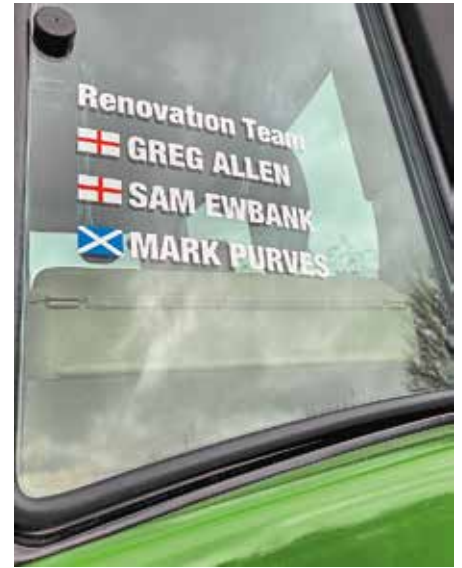
Sam Ewbank, Mark Purves and Greg Allen carried out the tractor's refurbishment in-house, putting in many hours outside work. Their attention to detail needs to be seen at first hand, with even the bonnet support brackets being passivated to replicate the original bronze finish on the steel.
